Hydrofoil Pioneers...

HIGH SPEED CRASH OF FRESH-1

by William M. Ellsworth

Reprinted from the book Twenty Foilborne Years -- The US Navy Hydrofoil HIGH POINT PCH-1

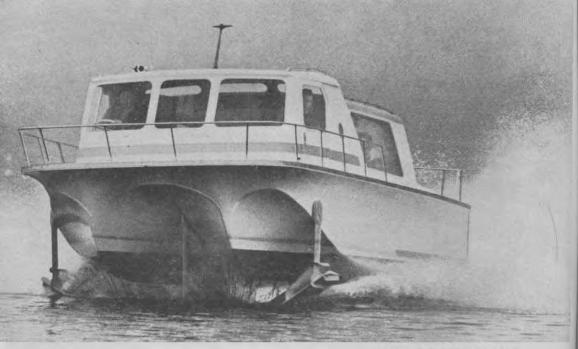
28-FOOT HYDRO MARINER cruiser for pleasure market has beam-width surface-piercing foils that retract hydraulically, giving boat docking draft of only 1 foot. It features car-style cockpit, picture-window cabin aft
