**FLAGSTAFF (PGH-1)**

USS FLAGSTAFF (PGH-1)

FLAGSTAFF (WPGH-1)

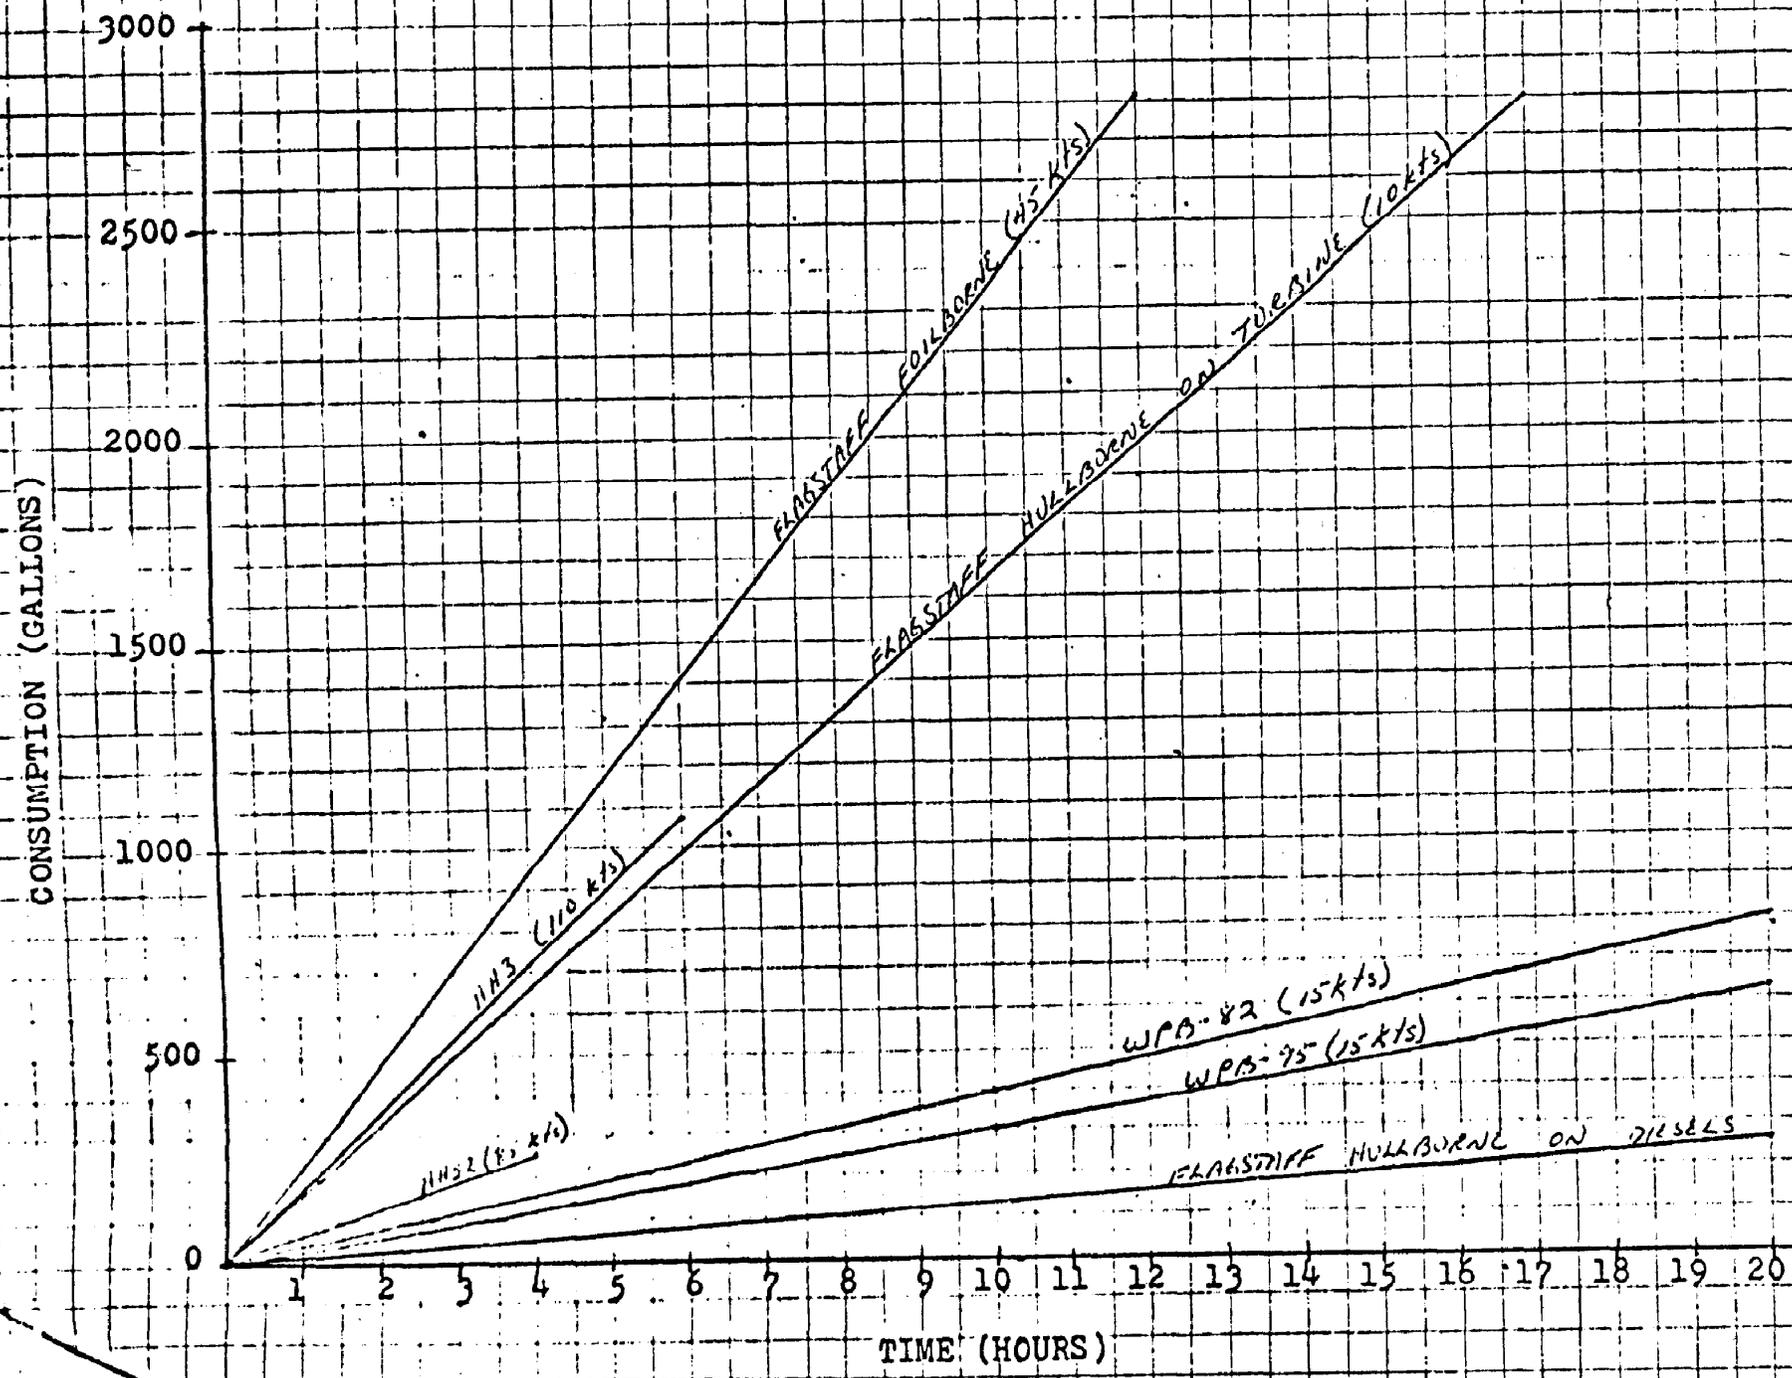
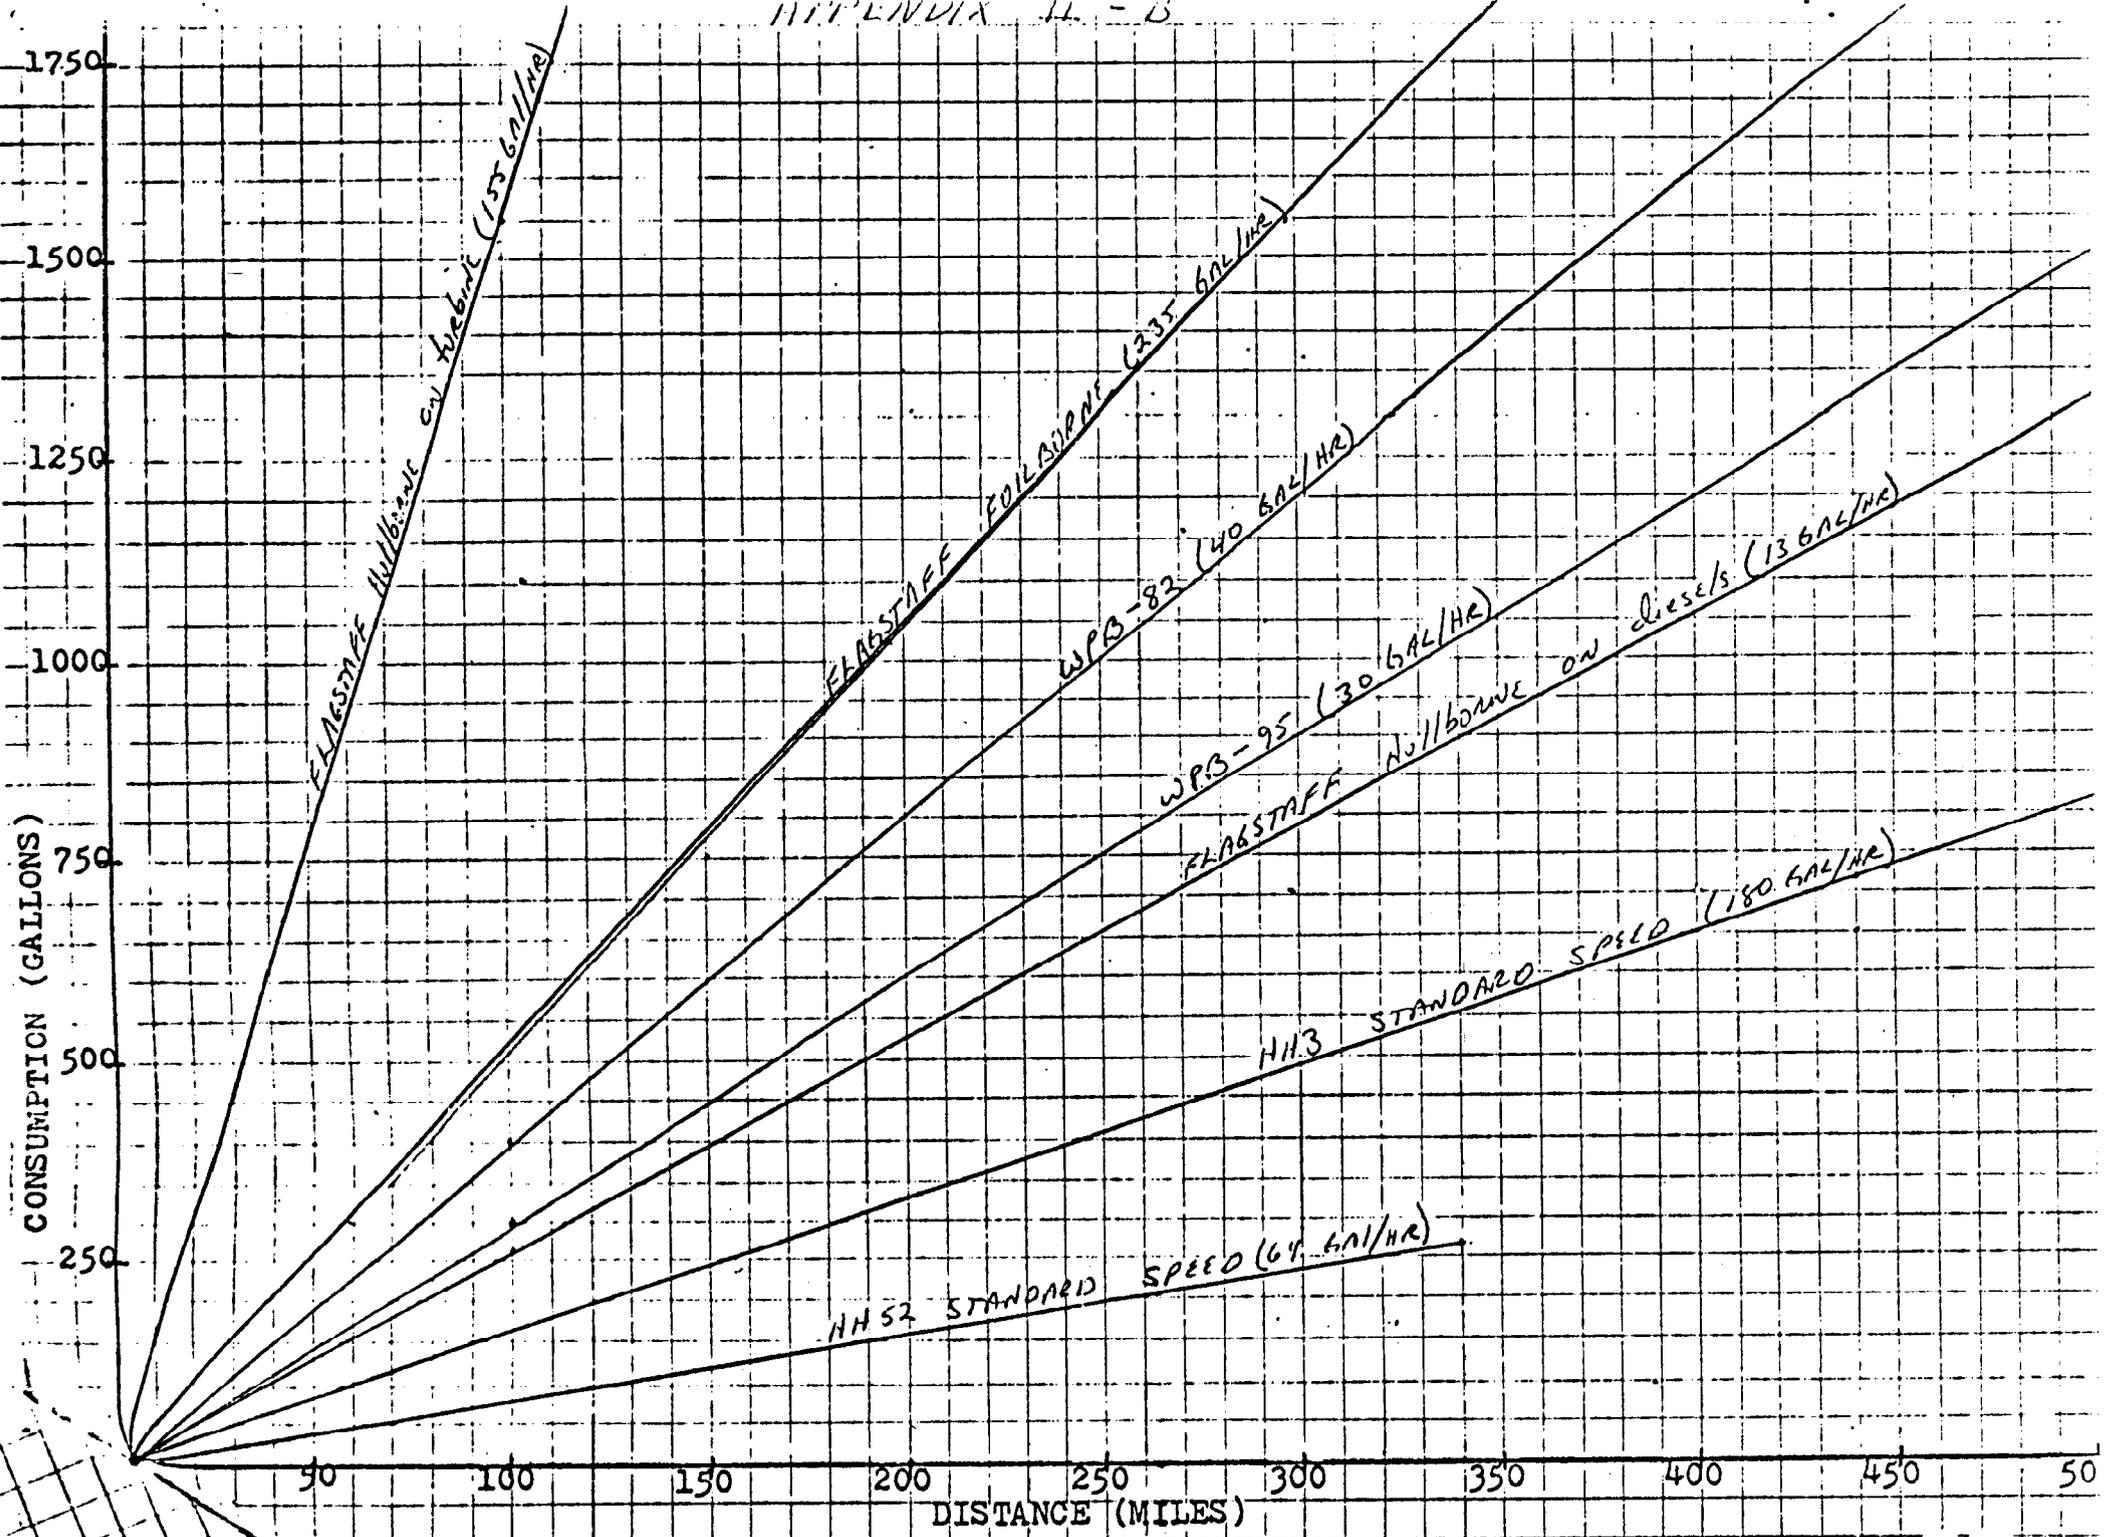
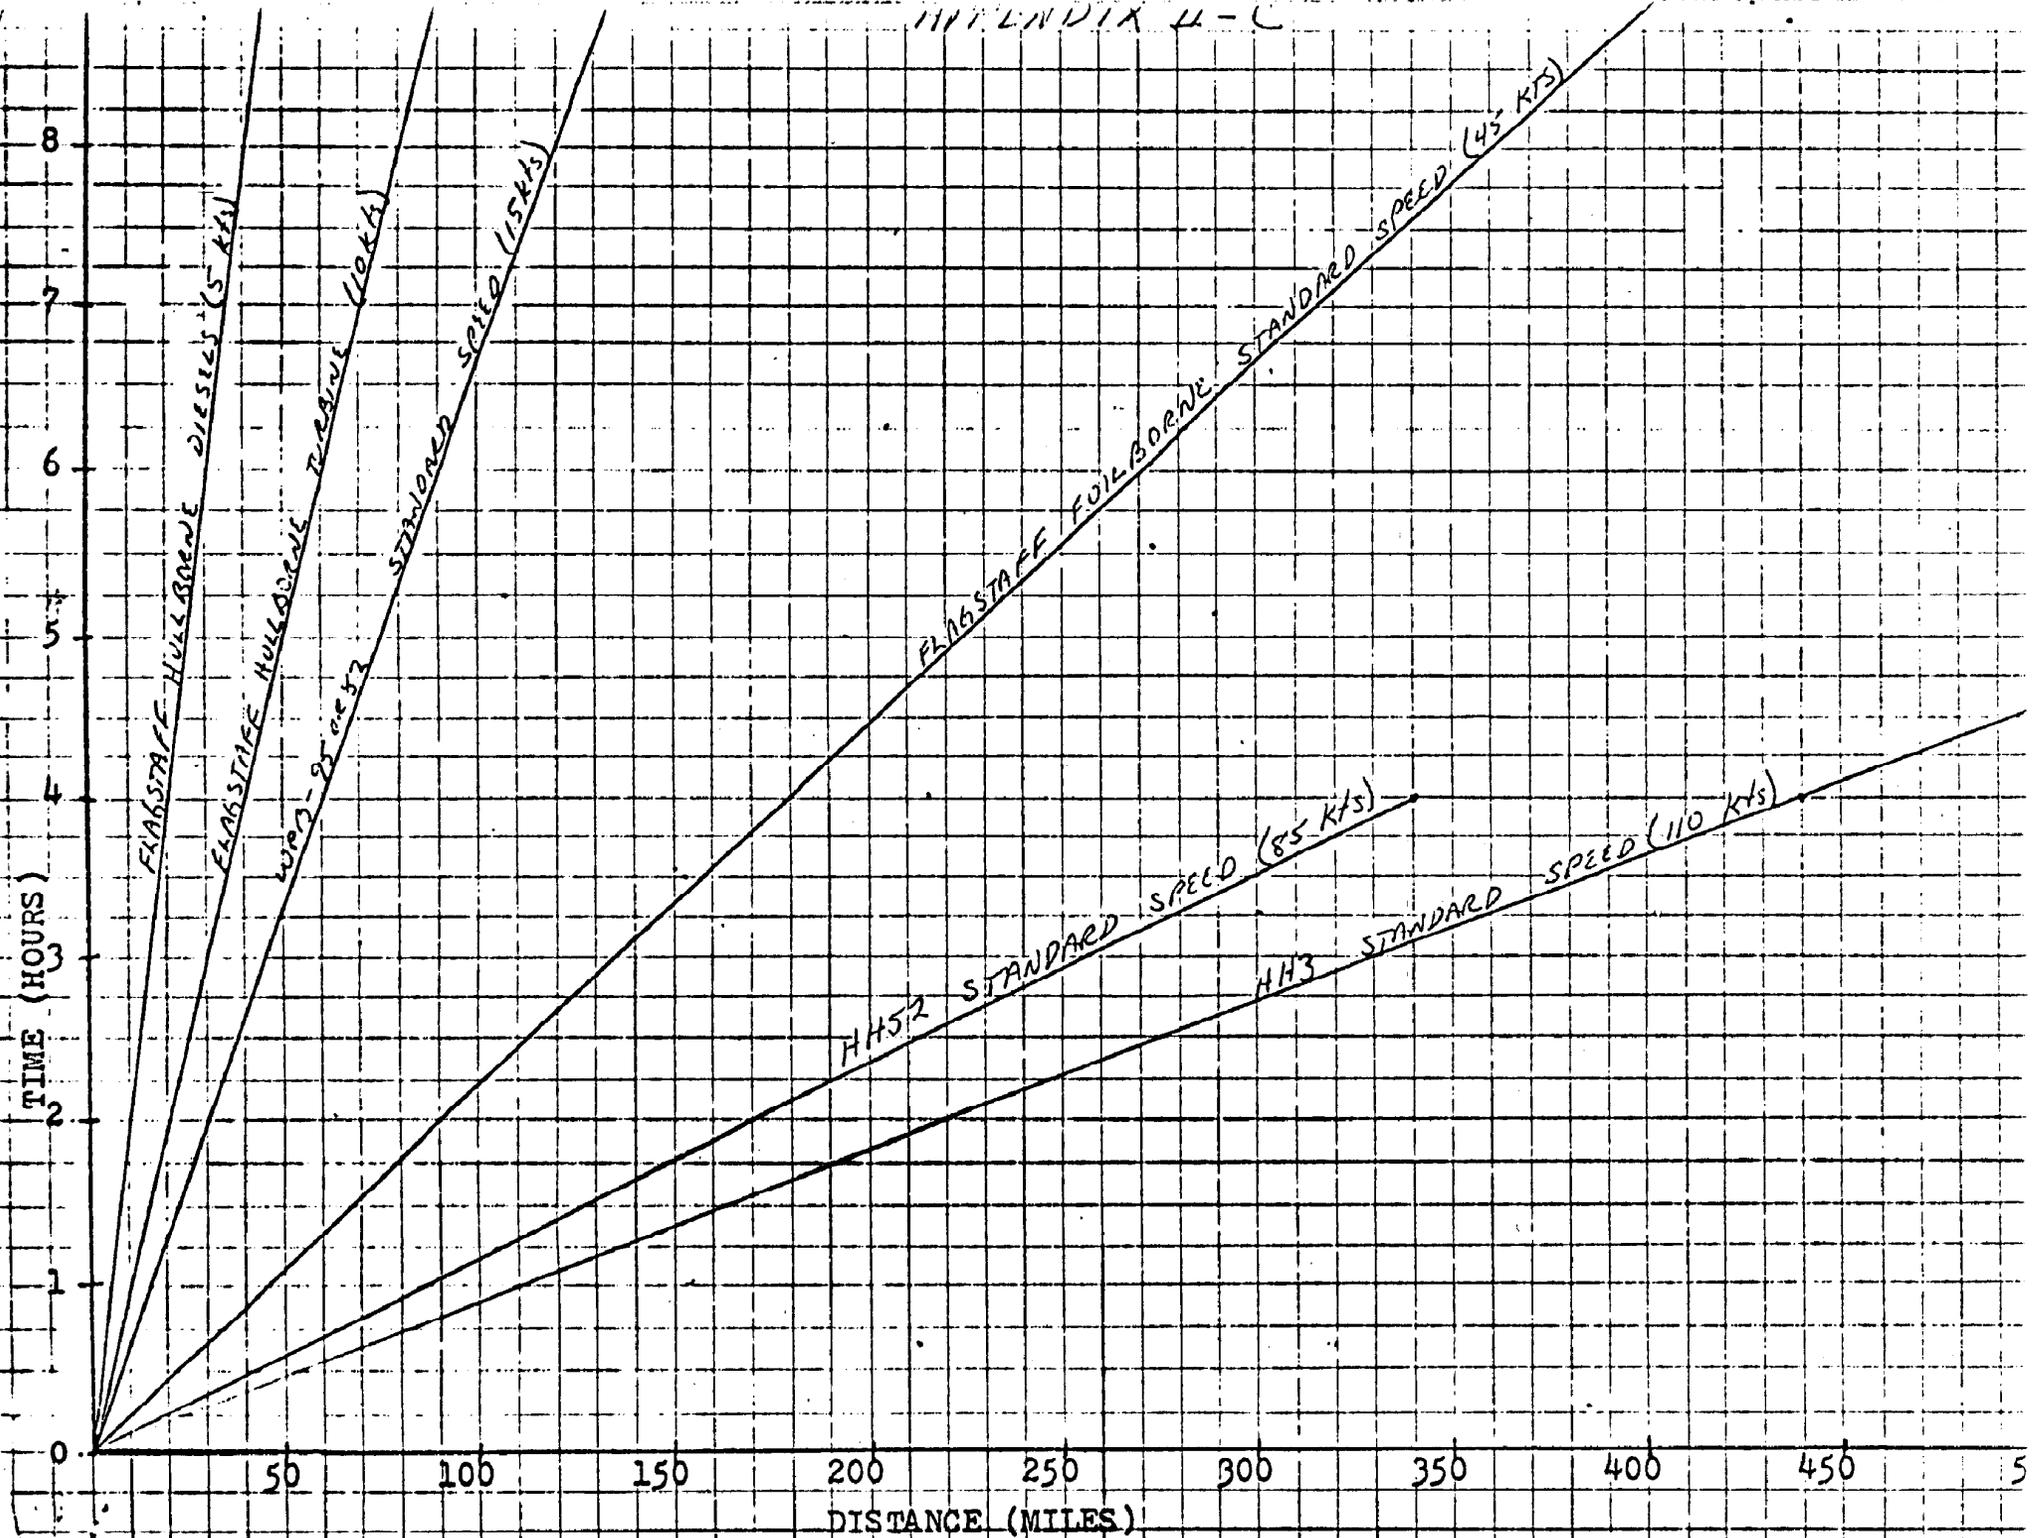
APPENDIX II - A

Appendix II shows FLAGSTAFF fuel consumption information, and can be utilized as desired to figure economical cruising under different scenarios (i.e. total foilborne operations, combined foilborne/hullborne on turbine or diesels, etc). A loss of endurance will definitely result under any condition where it is deemed necessary to use the turbine while hullborne.
