THE NATO PATROL MISSILE HYDROFOIL (PHM) SHIP AND WEAPONS SYSTEMS TECHNICAL EVALUATION PROGRAM

Cdr. Karl M. Duff, USN
LCdr. Henry Schmidt, Jr., USN
LCdr. Michael R. Terry, USN

13 July 1976

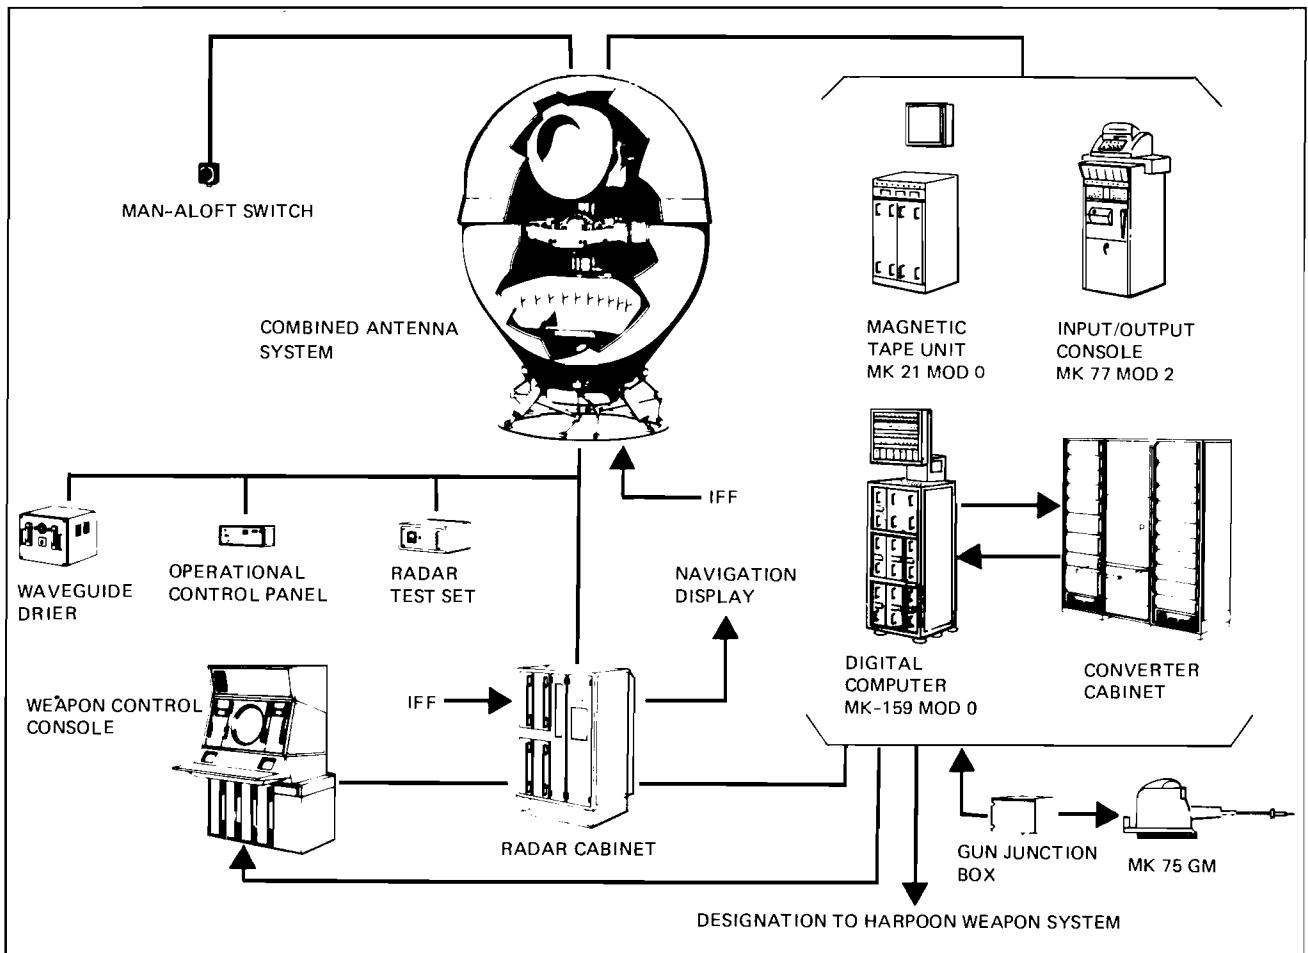
Figure 4. MK-94 (SIGNAAL WM-28) Fire Control System for PHM-1

Navy fast patrol boat S-143 class. (Figure 4) The FRG land based tests were utilized for system qualification and HSA land based tests were utilized for factory acceptance tests of the MK 94 installed in PHM-1. In parallel, the U.S. built version of MK 94 (MK 92 U.S. designation) was built by Sperry and operationally evaluated aboard USS TALBOT (FFG-4) for its suitability for the FFG-7 and PHM production programs. Both MK-94 and MK-92 qualification programs have been successfully completed. The OTO MELARA 76/62 76mm compact gun (U.S. MK 75 designation) has been used by many foreign navies for small ship armament including installation on board the Italian Navy hydrofoil ship SWORDFISH (P420), a variant of the U.S. Navy hydrofoil TUCUMCARI (PGS-2). In order to gain familiarity and qualify the gun prior to licensed production in the U.S., an OTO MELARA built MK 75 was put through a rigorous land based technical evaluation at the Naval Surface Weapons Center, Dahlgren, Virginia. In parallel, another OTO MELARA built MK 75 was placed aboard USS TALBOT for an operational evaluation with the MK-92 GFCS. The MK-75 Qualification program has been successfully completed and the Northern Ordnance Division of FMC has been licensed to build production units.

System and 76mm Rapid Fire Gun were modifications of foreign weapon development programs by the Dutch and Italians, respectively. The Hollandse Signaal Apparaten (HSA) Gun Fire Control System (U.S. MK-94 GFCS, Designation) employs a unique combination of search and track antennae and signal processing that has been developed over a number of years and had been selected for land based tests in the Federal Republic of Germany (FRG) and installation (as the WM 28) on the FRG

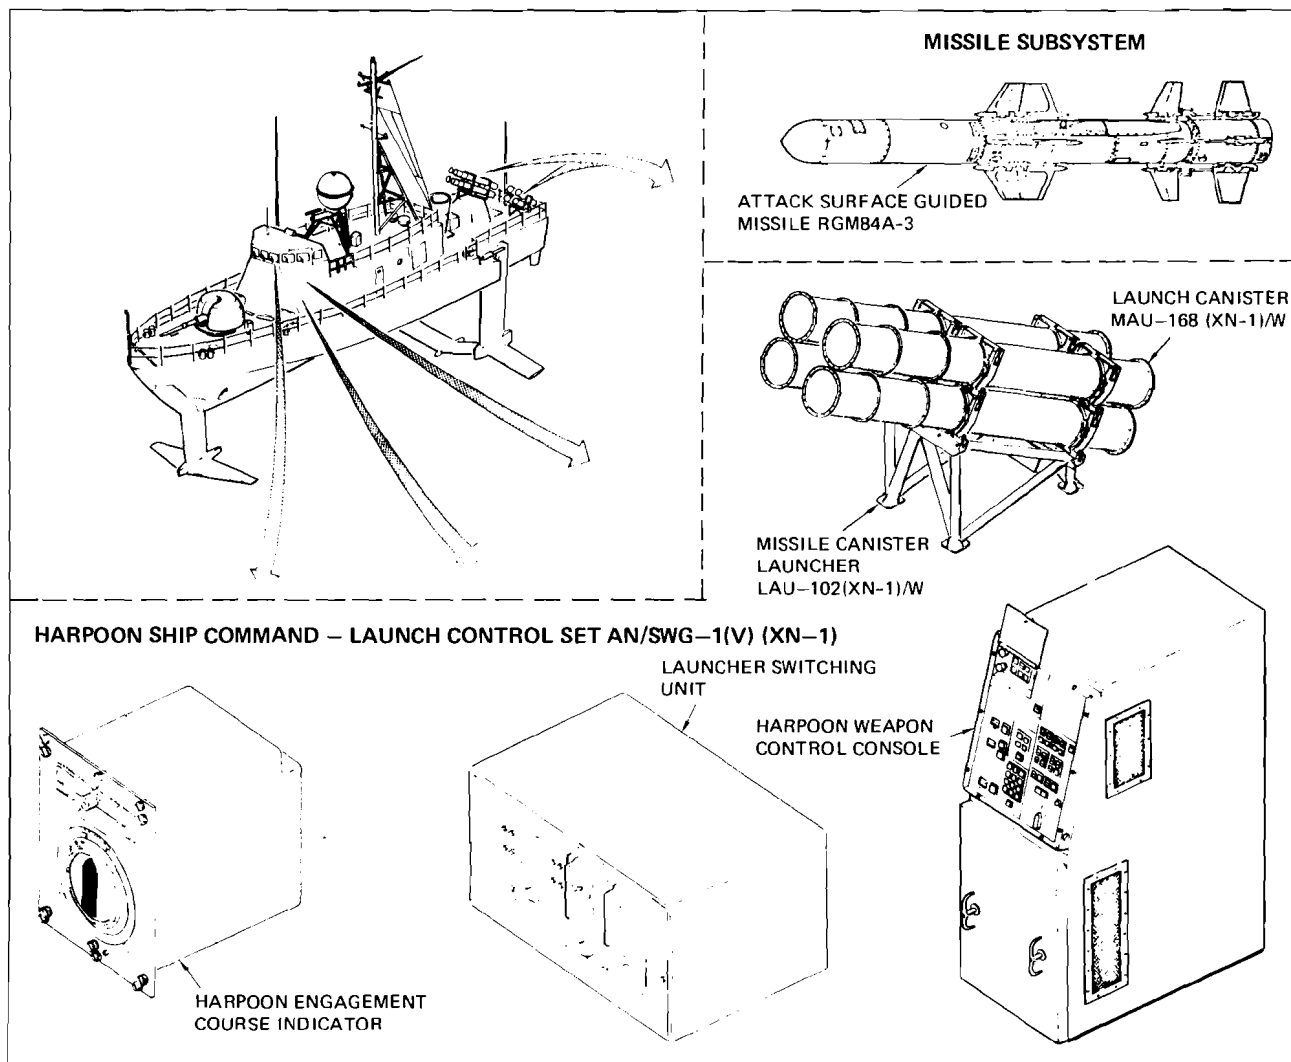
Figure 5. Harpoon System for PHM-1

The PHM primary weapon is a cannister launcher version of the Harpoon surface-to-surface missile built by McDonnell Douglas. It should be noted that the Harpoon system can function as a stand-alone system (Figure 5) or receive target information from the MK 94.

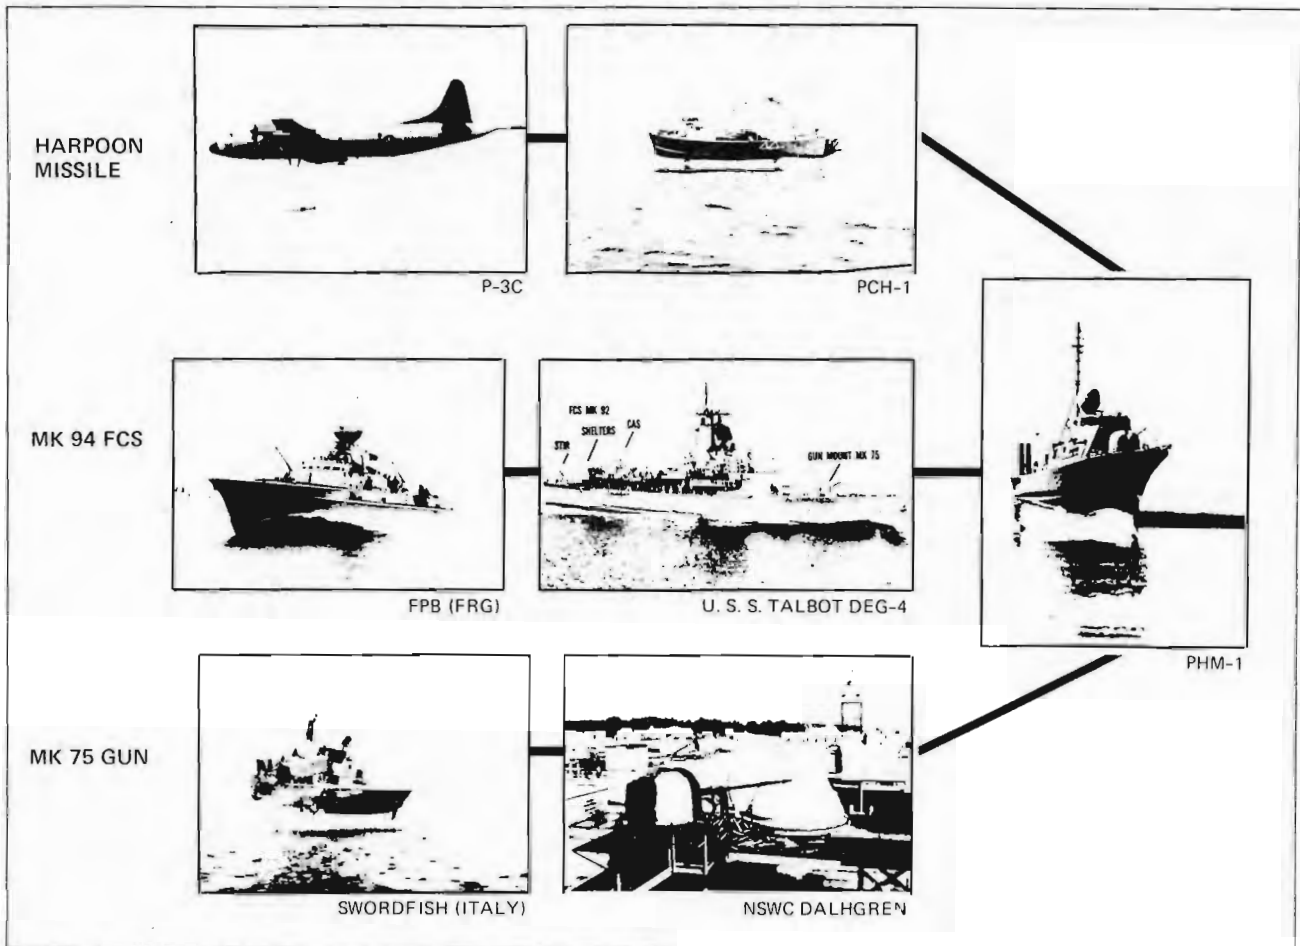
Figure 6. PHM-1 Weapons Systems

The airborne system is adapted for surface firing by the addition of a booster rocket. Shipboard launch from a ASROC box launcher was tested aboard USS DOWNES (FF 1070). The use of a fixed cannister launcher was first tested aboard the David Taylor Naval Ship Research Development Center's hydrofoil craft HIGH POINT (PCS-1) and later aboard the USS STERRETT (CLG 31) prior to installation and test aboard PEGASUS. The sources of major PHM combat systems and their qualification history is shown in Figure 6.

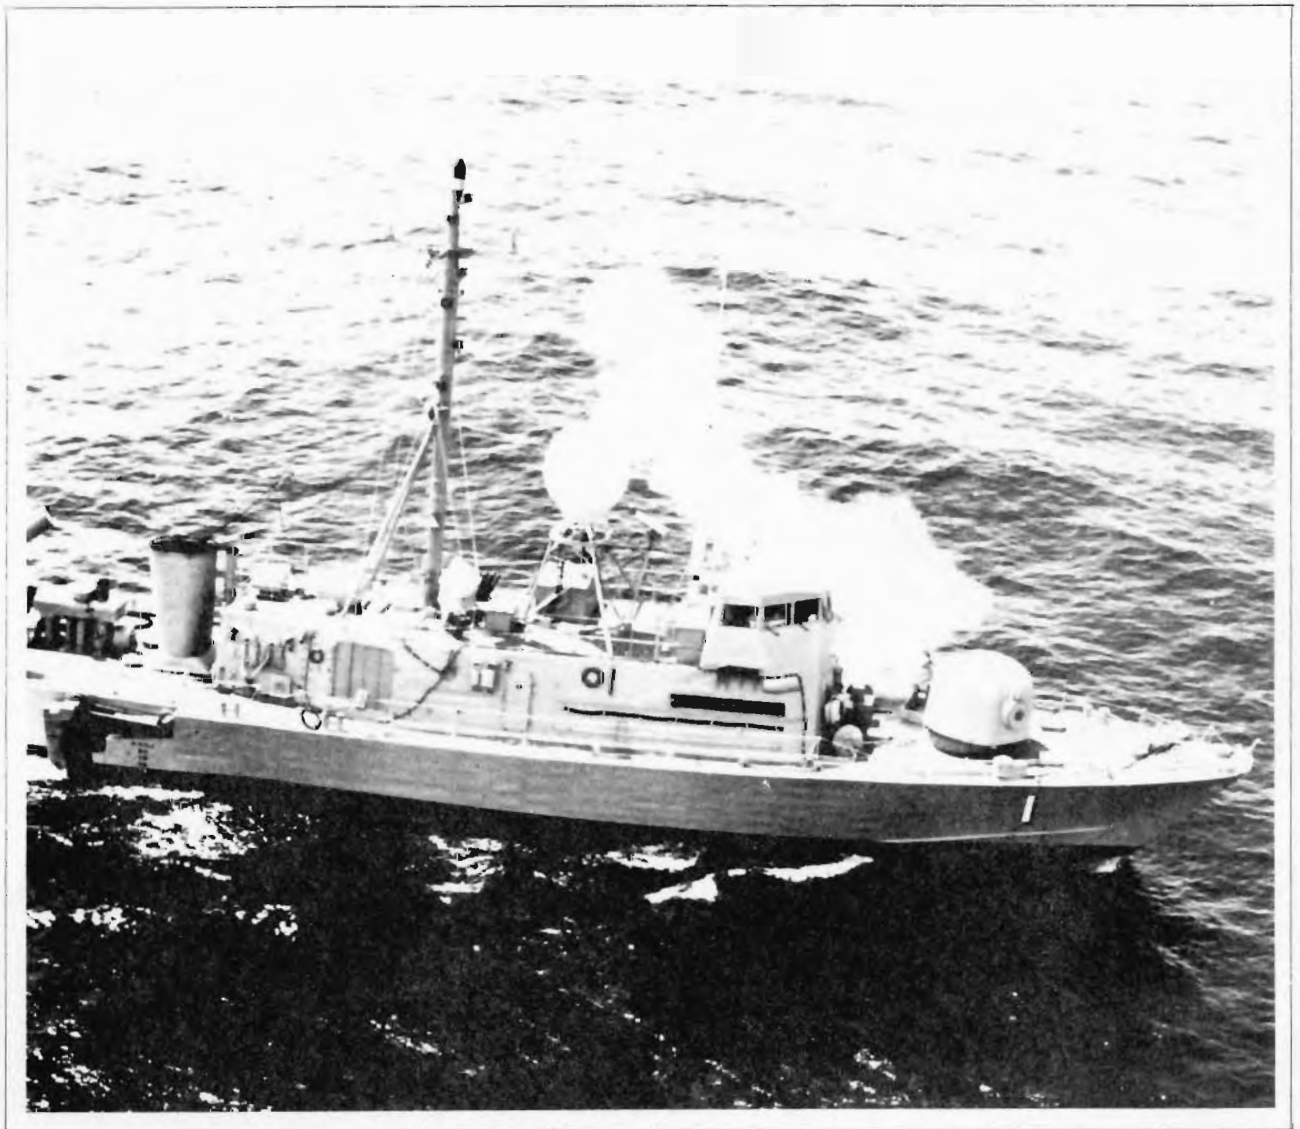
Figure 7. PHM-I Structural Firing

The first major Combat System Trial of the PHM Technical Evaluation (TECHEVAL) occurred on 26 June 1975 to test the MK-75 Gun in various firing modes and attitudes to validate the structural integrity of the platform. (See Figure 7.) During these tests, combat and platform systems were monitored and found to operate satisfactorily in the shock and blast environment of the gun. Magazine loading, ammunition handling, and gun mount safety procedures were validated during the trial.

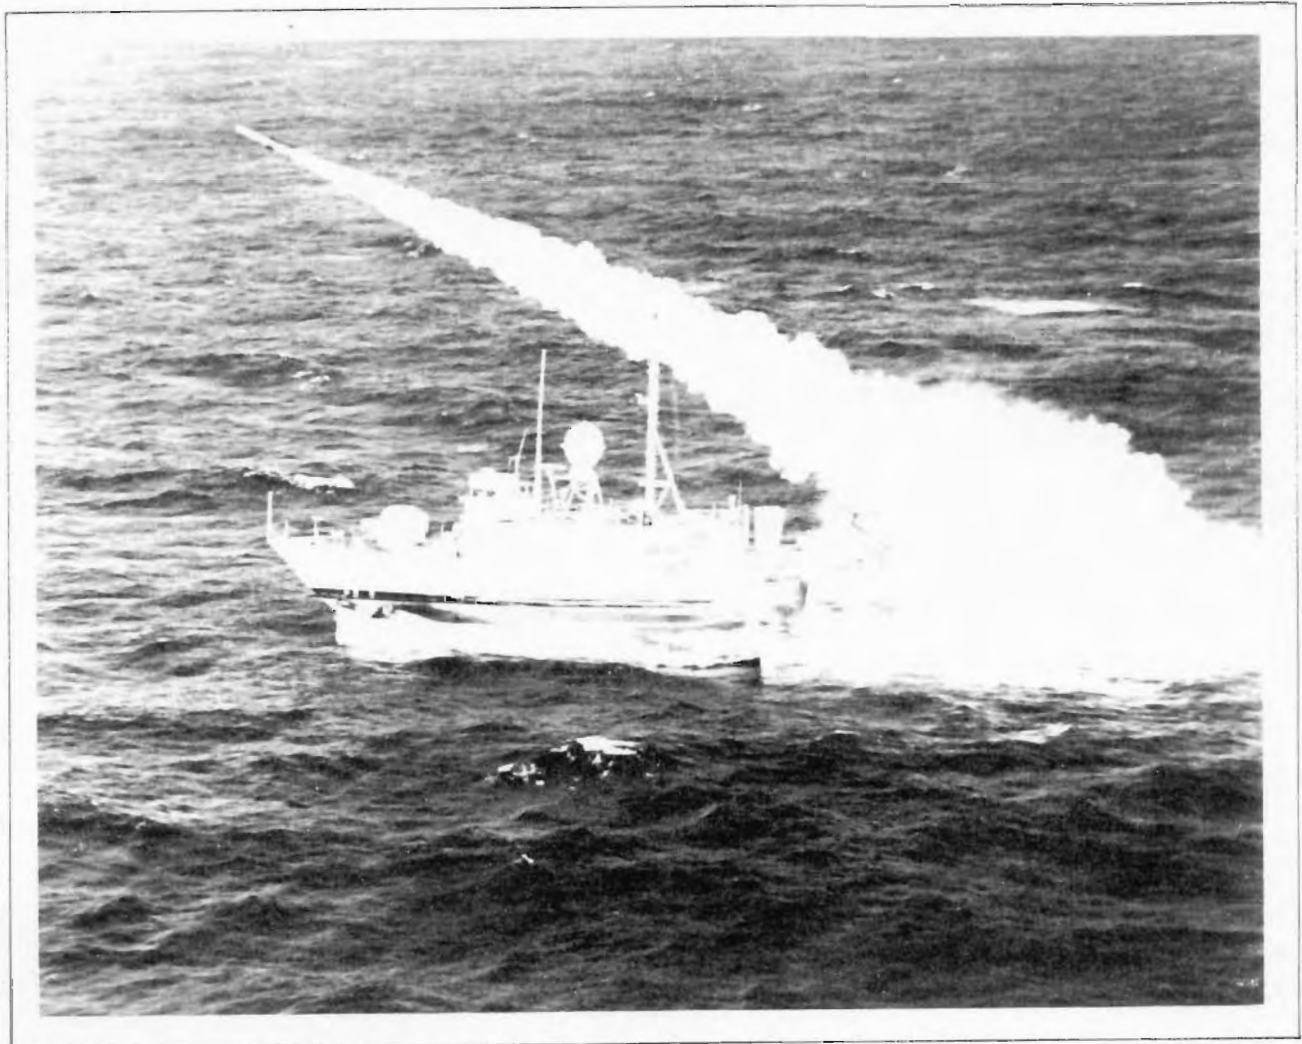
Figure 8. PHM-1 Harpoon Missile Firing

The Harpoon BTV launch while foilborne at over 40 knots (figure 8) proved the successful ship integration of the shipboard cannister launch system and established the marriage of the powerful harpoon tactical cruise missile and the high speed, high sea state, PHM hydrofoil system.

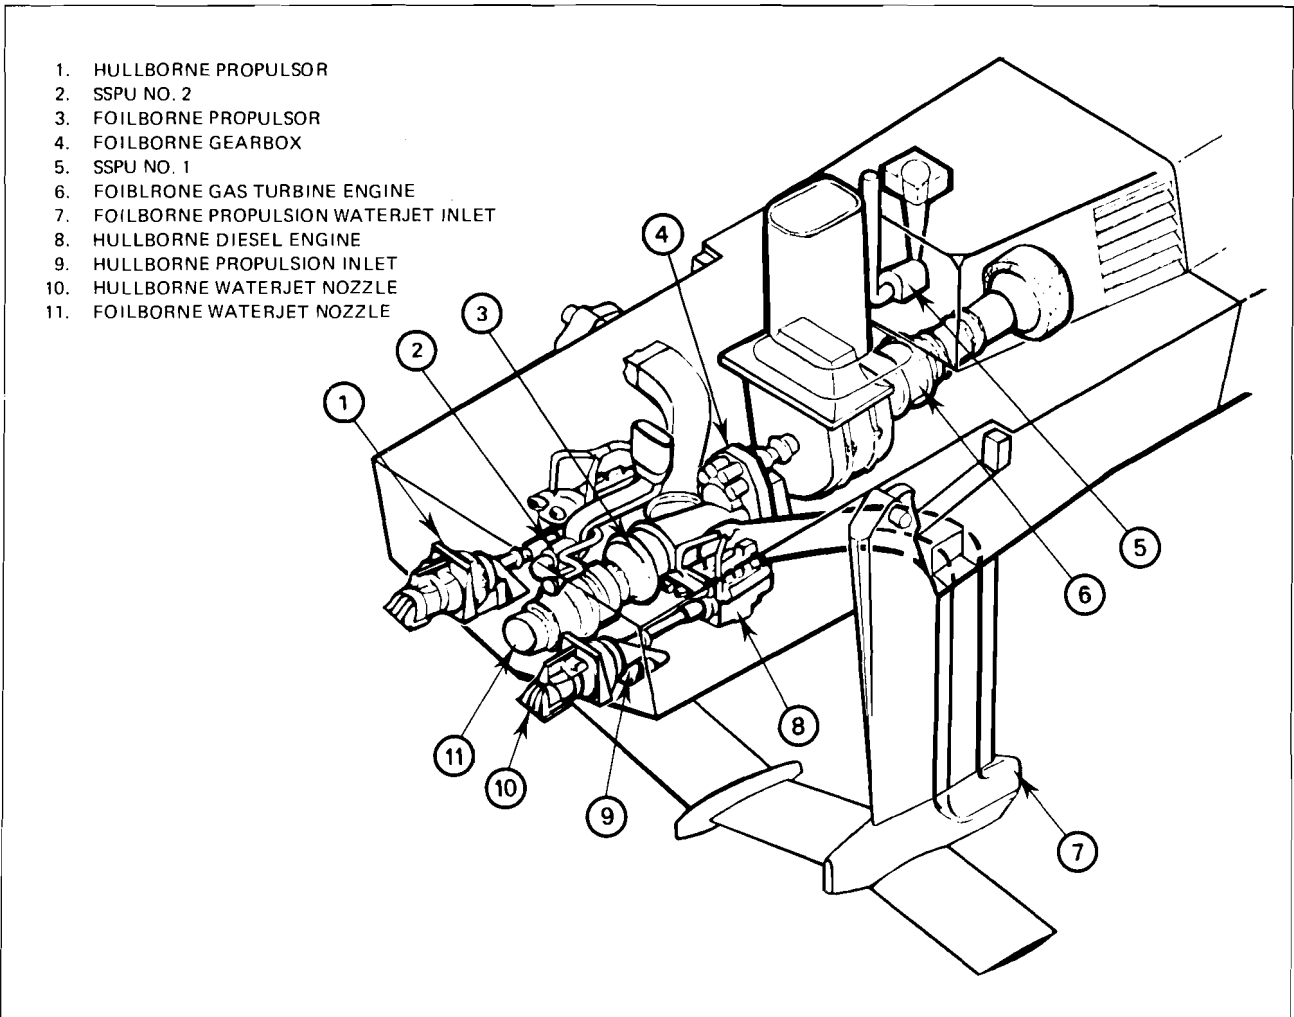
Figure 9. PHM Propulsion System Arrangements

The foilborne propulsor of the PHM illustrated in Figure 9, is composed of a two-stage waterjet pump and gearbox. The gearbox divides the input power into a low speed axial flow inducer stage and a high speed mixed flow impeller stage through concentric output shafts. The pump "pulls" a suction on the water inlets at the aft strut and foil pods at low speeds and operates at positive inlet pres-

sure at high speeds. The pump receives nominally 16,200 MHP and delivers 21,000 KGF thrust.

Mercedes diesel engines coupled through reduction gears and Zurn flexible couplings to Aerojet waterjet propulsors. (See Figure 9) During the first year of ship operations, there were several failures in this system. After approximately 50 hours of operation, the starboard clutch failed due to shearing of the pressure plate bolts. The bolt failure was identified as a fatigue problem. Bolts were replaced by larger size and the clutch pressure plate was modified. No further casualties in the clutch area have been experienced during an additional 1350 hours of operation.

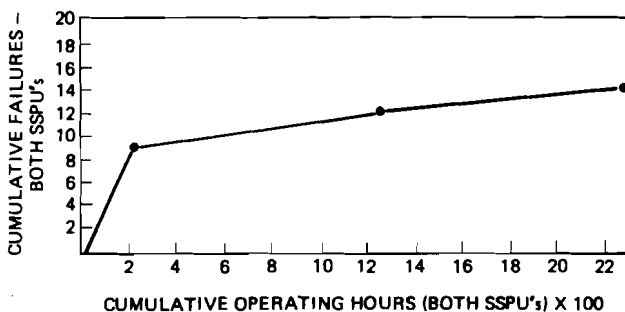
Figure 11. Failure History Ship Service Power Units

The majority of the problems associated with the SSPU's was associated with the driven equipment. Most of these problems were discovered and corrected within the first 200 operating hours of the units. With more than 2,200 cumulative operating hours to date, the SSPU's have proven to be extremely reliable units. The ship operators have been extremely pleased with the high reliability and instant availability of the units. Figure 11 provides the failure history of the SSPU's and their driven equipment.

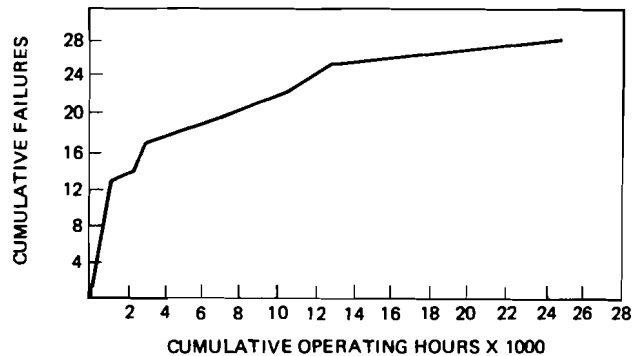
Figure 12a. 400 Hz/60 Hz Static Converter Failure History

It should be noted that during the first six months that the ship was deployed to Southern California, 12,000 operating hours were accrued on the converters with five failures. This equates to an improved average operating time between failures of 2400 hours since deployment.

The causes of the 400Hz/60Hz static converter failures aboard PHM can be classified as:
 1) component failures, 2) failures due to inadequate manufacturing quality control and, 3) interface incompatibilities with input and/or output loads. Each of these failure areas can be summarized as follows:

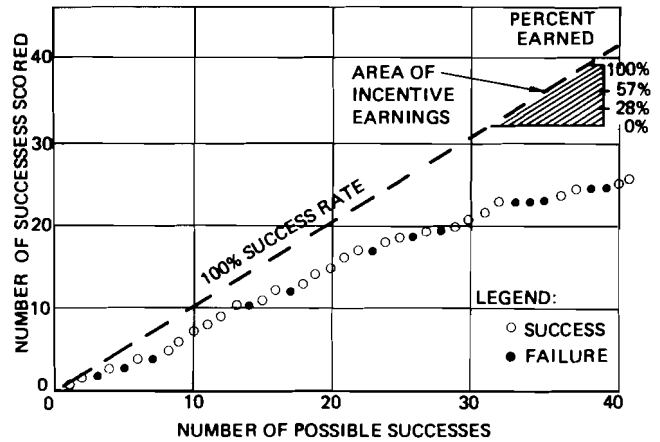
Figure 13. PHM-1 Ship Reliability Scoring Performance (Interim)

On this basis, the resulting technical incentive plan for performance over the first 40 contractor performance trials is depicted in Figures 13 through 16. As mentioned above, the scoring procedures established under the contract provide for elimination from the scoring results, any failures which, by agreement of the Navy Project Manager, is proven to have been due to a design deficiency or procedural error which is subsequently corrected by the contractor. In such a case, the applicable failures are to be ruled "no-score"; and additional scoring trials are to be conducted, necessary to complete the data base of 40 trials. At the time of this writing, prior to deletion of any "no-score" data, RELIABILITY results are shown in Figure 13. Correction of deficiencies in the main propulsion system and automatic control system, responsible for most of the failure scores, is expected to raise performance into the incentive scoring area prior to ship delivery.

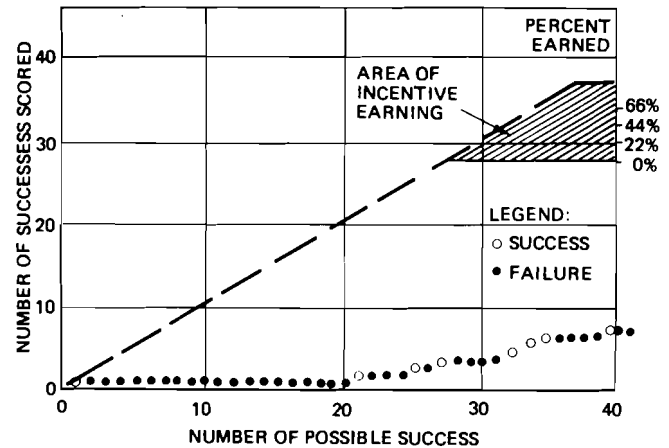
Figure 14. PHM-1 Equipment Availability Scoring Performance

Scoring in AVAILABILITY has demonstrated that an average of two to three equipments of those in the scoring matrix are down (inoperative) at the end of each voyage. In retrospect, this is not a surprising conclusion; and it appears that the incentive targets may have been somewhat severe. The AVAILABILITY scoring results are shown in Figure 14. Distribution of the number of failed equipments on each scoring voyage is shown in Figure 15.

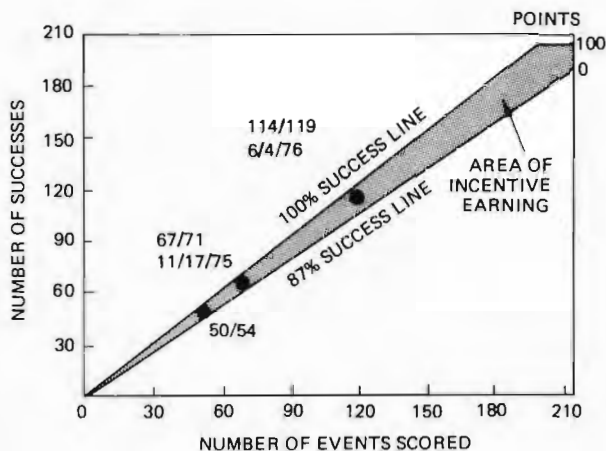
Figure 16. PHM-1 Specification Performance Success Scoring

The contractor has been quite successful in demonstrating required contract performance of the ship or its systems on the first demonstration attempt, achieving an average success rate of 96 percent to date. This is illustrated against his target incentive in Figure 16.

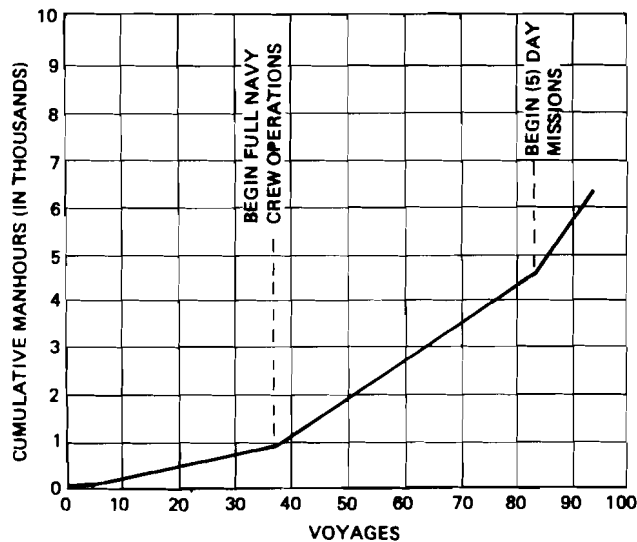
Figure 18. PHM-1 Cumulative Navy Crew Operating Experience

Table VII and Figure 18 illustrate the cumulative equipment time and Navy crew operating experience, respectively, which existed at the conclusion of PHM Technical Evaluation. Together with the prior figures, this data is illustrative of the effort necessary to bring a ship of this type to the point where it is ready to certify

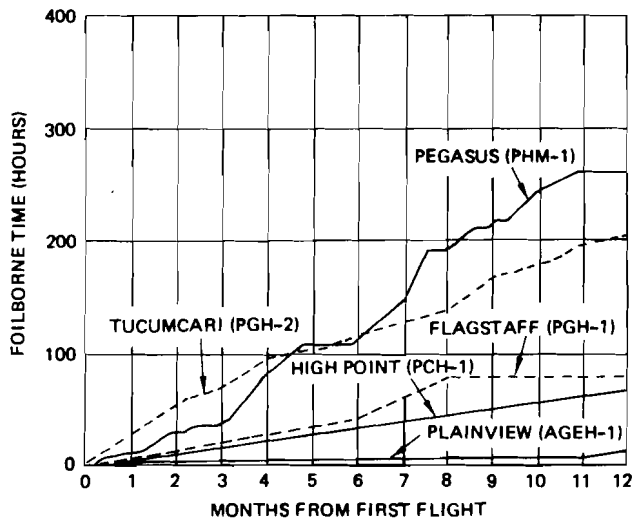
Figure 19. First Year Comparison of PHM-1 and Other U.S. Navy Hydrofoils

Comparative PHM-1 and earlier hydrofoil first-year operating experience is illustrated in Figure 19. This demonstrates clearly the remarkable reliability and pace of operations of PHM-1 during its first year despite the continuing interruption of main propulsion system problems and the much greater complexity of the PHM combat systems, test program, crew integration and deployment schedule compared to earlier hydrofoil programs.
