Hydrofoil Pioneers...

HIGH SPEED CRASH OF FRESH-1

by William M. Ellsworth

Reprinted from the book Twenty Foilborne Years -- The US Navy Hydrofoil HIGH POINT PCH-1

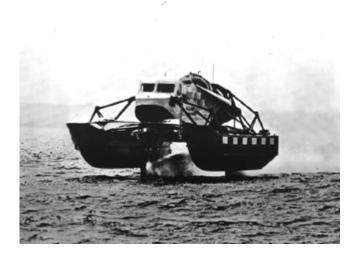
On 18 July 1963, Acceptance Trials with *FRESH-1* in a canard foil configuration were scheduled. Supervisor of Shipbuilding (SUPSHIP-13) representative Pete Sias was aboard and occupied the co-pilot seat. Vern Salisbury, Boeing test pilot, as usual occupied the left seat at the controls. Salisbury, a Colonel in the Marine Corps Air Reserve, had been recruited from the Boeing flight line where he had been a test pilot for several years. In the rear seat, Bob Hubbard, manager of the Boeing autopilot development team, manned the instrument station. Data from the extensive instrumentation suite was recorded and also telemetered to a shore station where it was continually monitored by Boeing engineers during trials. The trial on that afternoon was ill-fated. During the high speed run, the craft completely capsized. In a taped interview of Vern Salisbury on 22 February 1984, he recalled events during the accident.

[9 May 98] As for the "The Fate of *FRESH-1*", Bill Ellsworth's article is not clear as to the cause of the accident. I being Pete Sias's assistant on this project as well as the *HIGH POINT* construction project, was assigned to the accident investigation board. It was determined that the cause of the accident started from the foils ventilating to the extent that the trailing edge flaps were working in air rather than water. Previous to the accident, Bob Hubbard in the co-pilot seat would see the upward drift on height and manually increase the flap angle to regain fluid flow over the foil before full ventilation occurred. In studying the combination of traces from the telemetered data, it turned out that a combination of the rewetting of the foils at the particular moment that the helm inputs to the trailing edge rudder which was also ventilating and rewetting caused the roll over of *FRESH-1*. The board concluded that if the helm was held steady and throttles were chopped, the ship would most likely have landed on the hull without the roll over. Other safety features were recommended and incorporated, including an escape hatch and push to release door locks.
